PIC18F1XK22/LF1XK22 Family

Silicon Errata and Data Sheet Clarification

The PIC18F1XK22/LF1XK22 family devices that you have received conform functionally to the current Device Data Sheet (DS41365C), except for the anomalies described in this document.

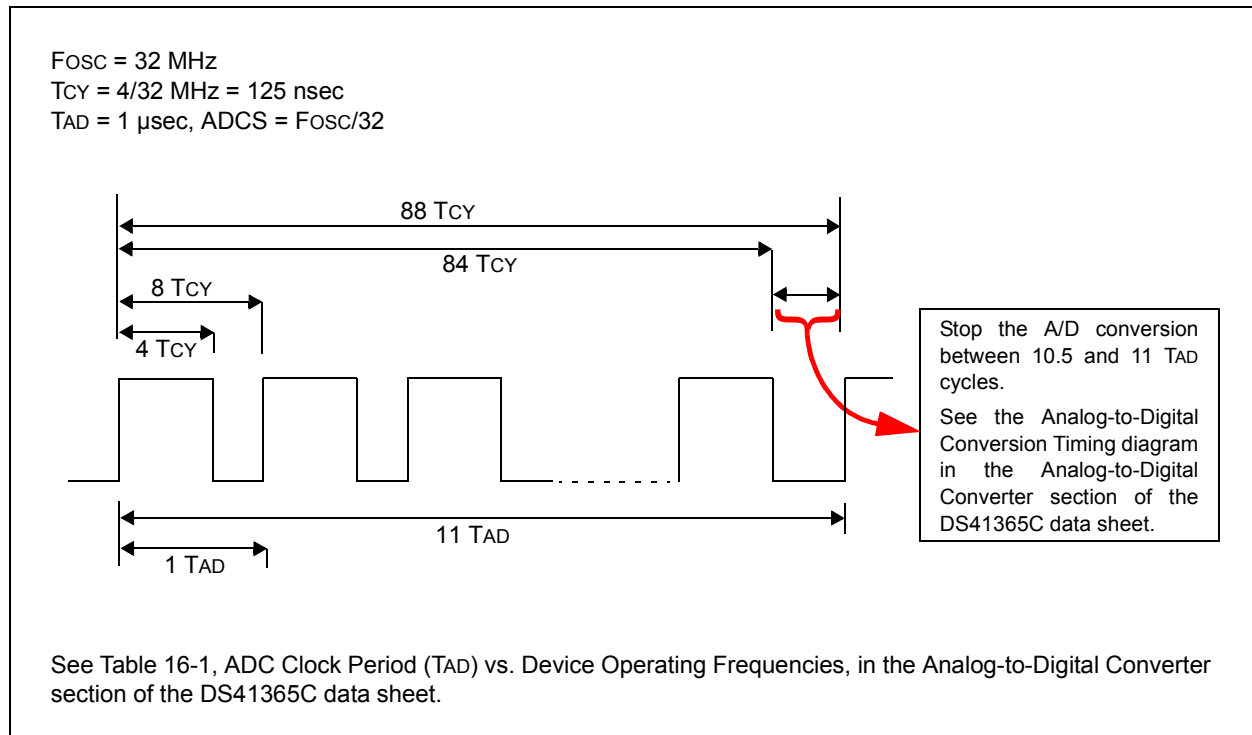
FIGURE 1: INSTRUCTION CYCLE DELAY CALCULATION EXAMPLE

- 1.2 Under certain device operating conditions, the ADC conversion may not complete properly. When this occurs, the ADC Interrupt Flag (ADIF) does not get set, the ADGO/DONE bit does not get cleared, and the conversion result does not get loaded into the ADRESH and ADRESL result registers.

In Figure 1, 88 instruction cycles (Tcy) will be required to complete the full conversion. Each TAD cycle consists of 8 Tcy periods. A fixed delay is provided to stop the A/D conversion after 86 instruction cycles and terminate the conversion at the correct time as shown in the figure above.

Note: The exact delay time will depend on the choice of Fosc and the TAD divisor (ADCS) selection. The Tcy counts shown in the timing diagram above apply to this example only. Refer to Table 3 for the required delay counts for other configurations.

Method 2: Provide a fixed delay in software to stop the A-to-D conversion manually, after all 10 bits are converted, but before the conversion would complete automatically. The conversion is stopped by clearing the GO/DONE bit in software. The GO/DONE bit must be cleared during the last ½ TAD cycle, before the conversion would have completed automatically. Refer to Figure 1 for details.
