### Applicability

This document applies to the part numbers of STM32F051x4/x6/x8 devices listed in [Table 1](#) and their variants shown in [Table 2](#).

# 1 Summary of device errata

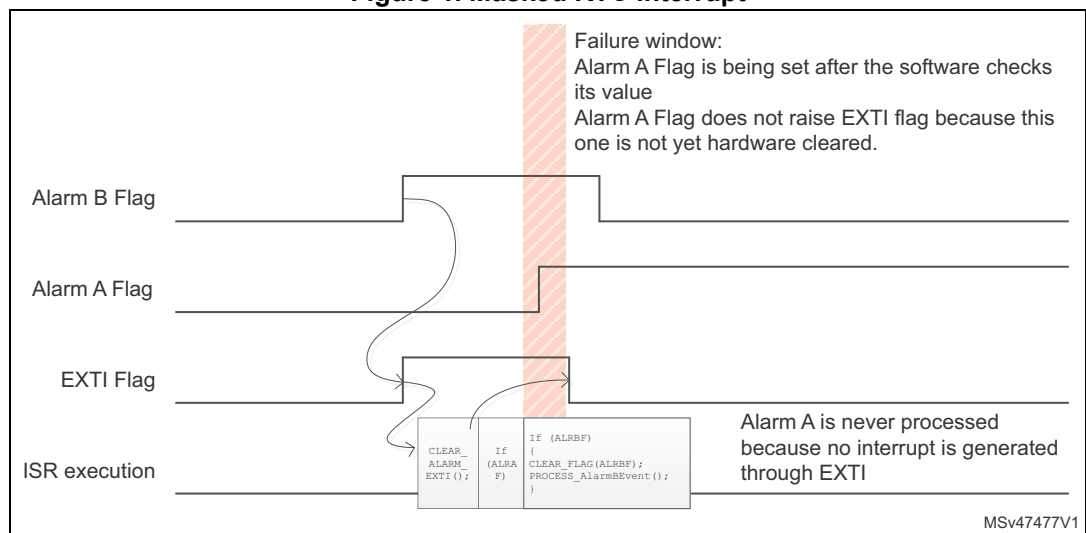
Figure 1. Masked RTC interrupt

The following code example and figure illustrate the failure mechanism: The Alarm A event is lost (fails to generate interrupt) as it occurs in the failure window, that is, after checking the Alarm A event flag but before the effective clear of the EXTI interrupt flag by hardware. The effective clear of the EXTI interrupt flag is delayed with respect to the software instruction to clear it.

In the interrupt service routine, apply three consecutive event flag checks - source one, source two, and source one again, as in the following code example:

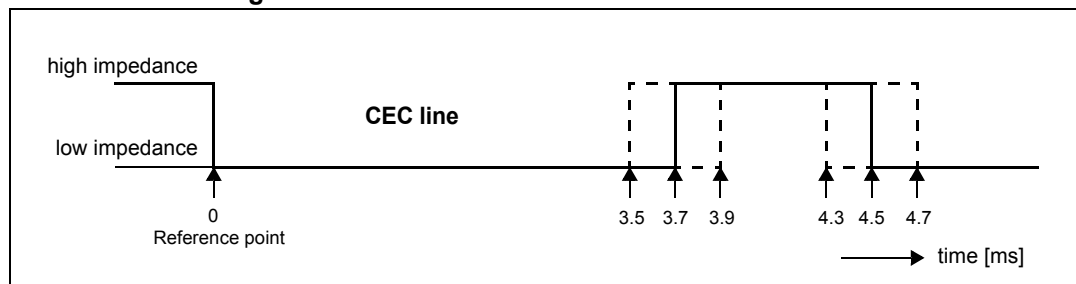
Figure 2. HDMI-CEC start bit format with tolerances

The start bit timing standard tolerances are shown in [Figure 2](#). The start bit is initiated by the device by driving the CEC line low (reference point). After 3.7 ms, the device releases the CEC line and starts checking its level. The following conditions must be met for the start bit to be valid:

If one of these conditions is not met, the transmission is aborted and never automatically retried. No error flag is set and the TXSOM (Tx Start Of Message) bit is not cleared.

The only way to detect this error is for the application software to start a timeout when setting the TXSOM bit, restart it upon ARBLST or any RX event (as the transmission can be delayed by interleaved reception), and stop it upon TXBR (proof that the start bit was transmitted successfully) or TXEND event, or upon any TX error (which clears TXSOM). If the timeout expires (because none of those events occurred), the application software must restart the HDMI-CEC peripheral and retransmit the message.
