Applicability

This document applies to the part numbers of STM32F042x4/x6 devices listed in [Table 1](#) and their variants shown in [Table 2](#).

[Section 1](#) gives a summary and [Section 2](#) a description of device limitations and documentation errata, with respect to the device datasheet and reference manual RM0091.

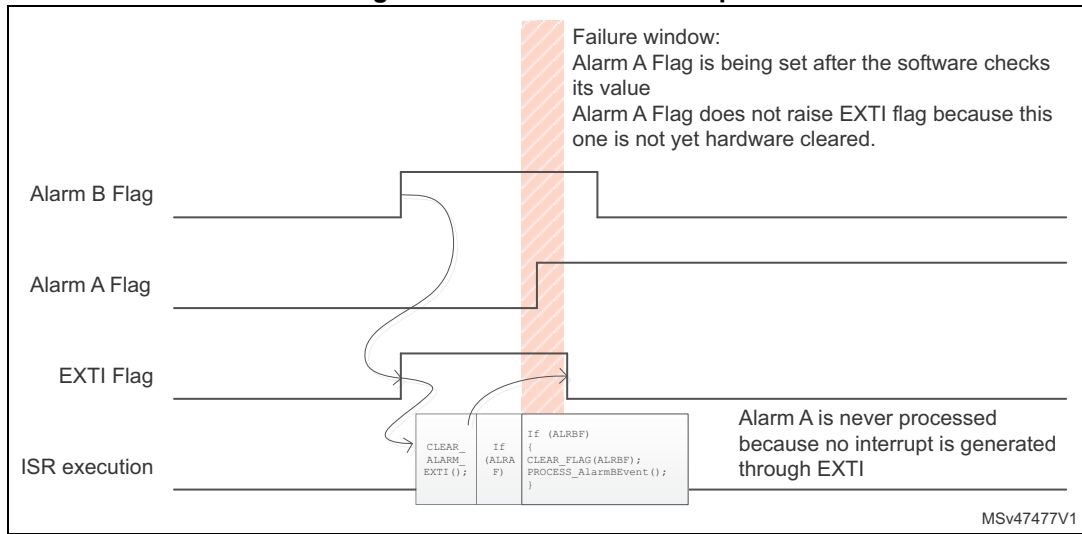
Figure 1. Masked RTC interrupt

2.7.4 RTC interrupt can be masked by another RTC interrupt

One RTC interrupt can mask another RTC interrupt if both share the same EXTI configurable line, such as the RTC Alarm A and Alarm B, of which the event flags are OR-ed to the same EXTI line (refer to the **EXTI line connections** table in the **Extended interrupt and event controller (EXTI)** section of the reference manual).

The following code example and figure illustrate the failure mechanism: The Alarm A event is lost (fails to generate interrupt) as it occurs in the failure window, that is, after checking the Alarm A event flag but before the effective clear of the EXTI interrupt flag by hardware. The effective clear of the EXTI interrupt flag is delayed with respect to the software instruction to clear it.

In the interrupt service routine, apply three consecutive event flag checks - source one, source two, and source one again, as in the following code example:

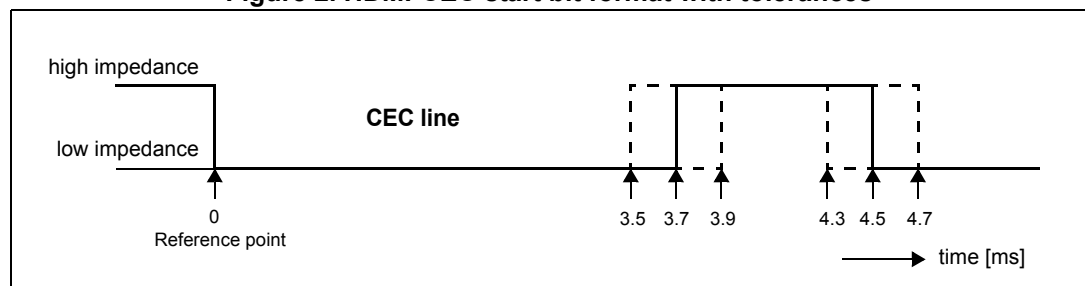
Figure 2. HDMI-CEC start bit format with tolerances

This failure is unlikely to happen as the CEC start bit corruption by another device can only occur if that device does not respect the CEC communication protocol.

The start bit timing standard tolerances are shown in [Figure 2](#). The start bit is initiated by the device by driving the CEC line low (reference point). After 3.7 ms, the device releases the CEC line and starts checking its level. The following conditions must be met for the start bit to be valid:

If one of these conditions is not met, the transmission is aborted and never automatically retried. No error flag is set and the TXSOM (Tx Start Of Message) bit is not cleared.

The only way to detect this error is for the application software to start a timeout when setting the TXSOM bit, restart it upon ARBLST or any RX event (as the transmission can be delayed by interleaved reception), and stop it upon TXBR (proof that the start bit was transmitted successfully) or TXEND event, or upon any TX error (which clears TXSOM). If the timeout expires (because none of those events occurred), the application software must restart the HDMI-CEC peripheral and retransmit the message.
