SPC564Axx/RPC564Axx/SPC56ELxx/RPC56ELxx devices
Exception handling and single/double bit error

Introduction

This document provides an overview of SPC564Axx/RPC564Axx/SPC56ELxx/RPC56ELxx exception handling with main focus on different kinds of exception that the application code may face during the runtime like single and double bit errors in memories, MPU protection violation, AIPS access protection violation and others.

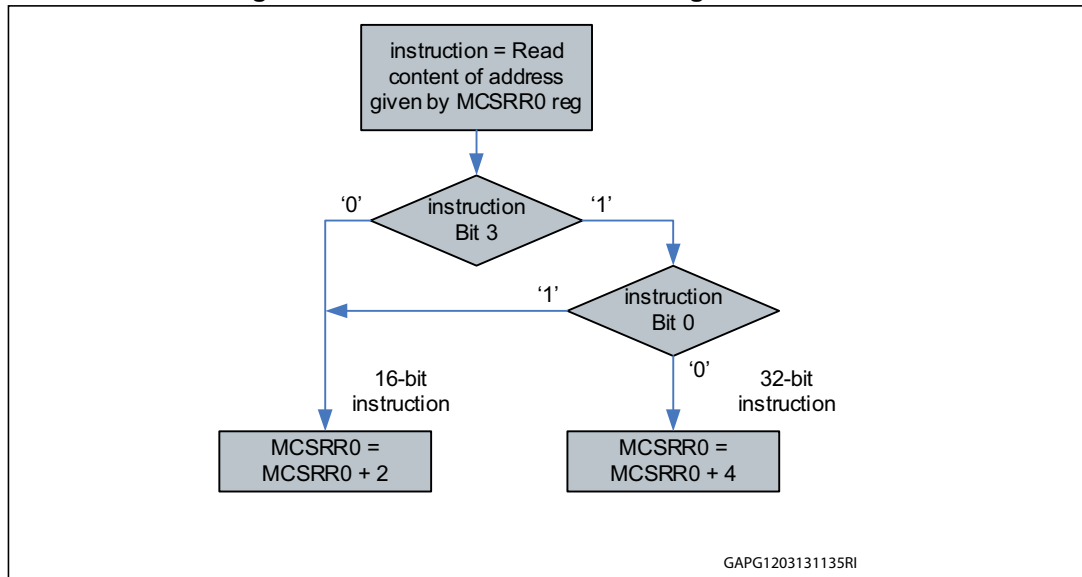
Figure 2. Modification of MCSRR0 register content

In case the exception cause of the exception cannot be removed, MCSRR0 register value is modified in a way that it takes the address of the following instruction. This prevents re-execution of the faulty instruction and retriggering the machine check exception.

Modification has to consider VLE instruction coding in case the interrupted process is implemented in VLE coding and the value increased according to the length of the faulty instruction pointed by the current MCSRR0 register content, see [Figure 2](#).

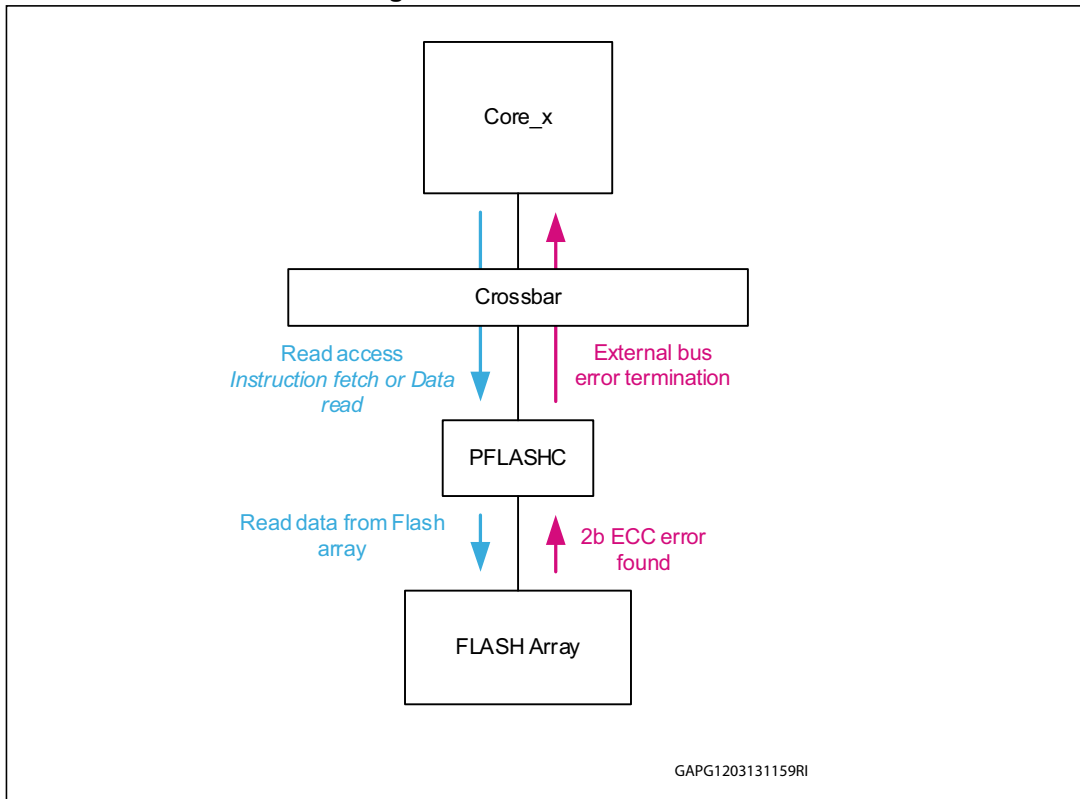
Figure 4. Flash 2b ECC error

Platform flash memory controller (PFLASHC) terminates bus transaction between CPU and PFLASHC controller in case the Flash memory array signals 2b ECC problem during read access. This leads to machine check exception because of *bus_error* termination.
