Cisco TelePresence SX and MX Series

Collaboration Endpoint Software 8

D15314.04

May 2016

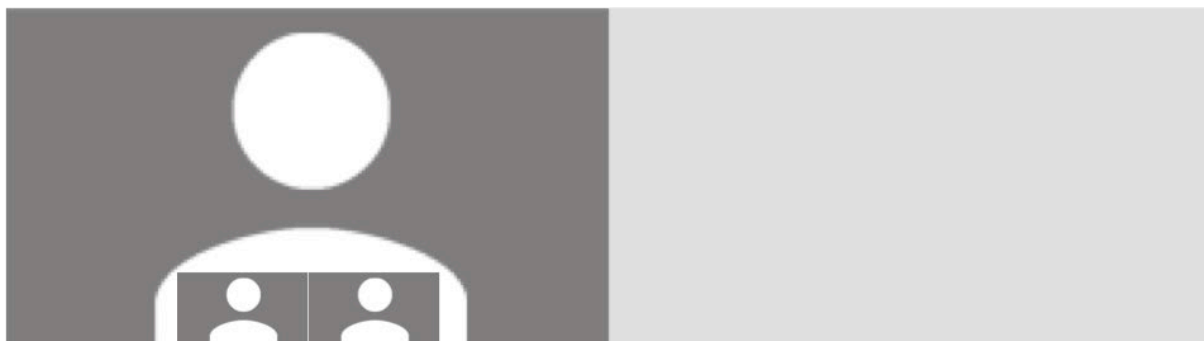
The above example shows a two-screen system in a conference where Multistream is not enabled. The endpoint is receiving only one transcoded stream from the Cisco TelePresence Server.

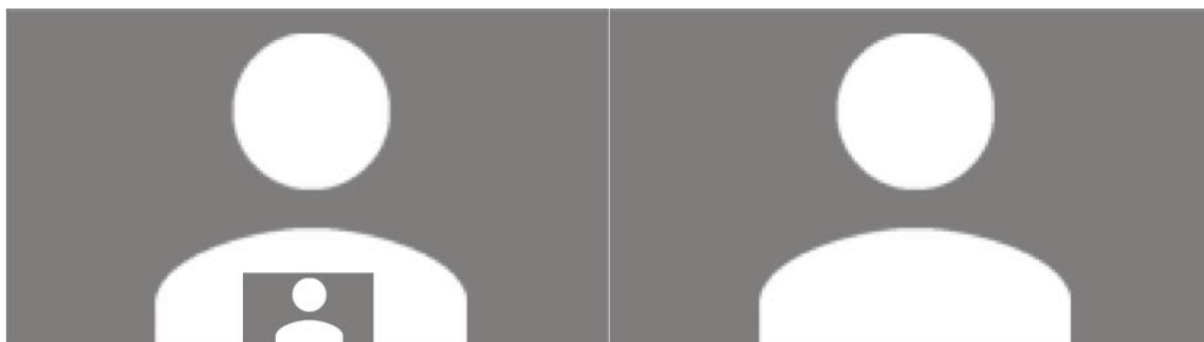
The above example shows the same conference with Multistream enabled.
